FULL RESERVE STUDY

The Lakes of Woodbridge Condominium Association

Portage, Michigan
October 21, 2015

Inspection Date: October 21, 2015. We conducted the original Reserve Study in 1994.

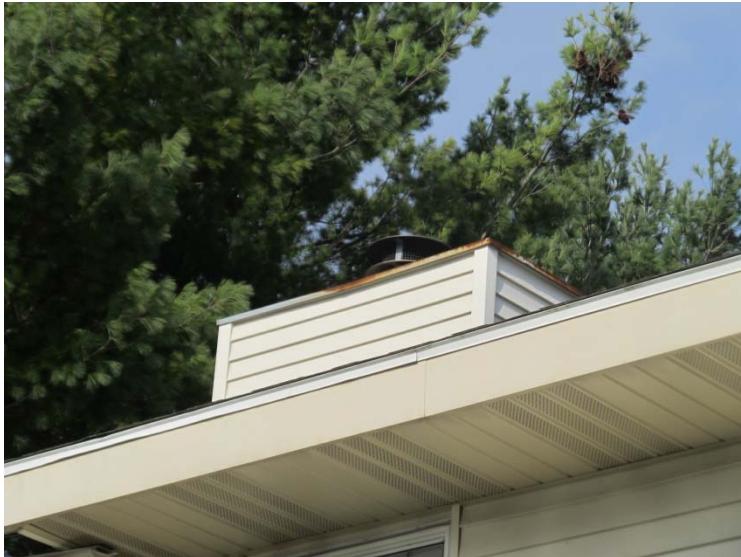
Chimney Caps, Metal - The Lakes of Woodbridge maintains 145 metal chimney caps. The chimney caps are original and in good overall condition based on our visual inspection from the ground. We note isolated rust as shown on Page 5.4 of **Photographs**. Chimney caps of this type have useful lives of up to 25 years. Based on condition, we recommend the Association anticipate replacement of the chimney caps and related flashing beginning by 2026 and concluding by 2029 in coordination with roof replacement. We depict this information on Line Item 1.140 of **Reserve Expenditures**.

Chimney cap rust

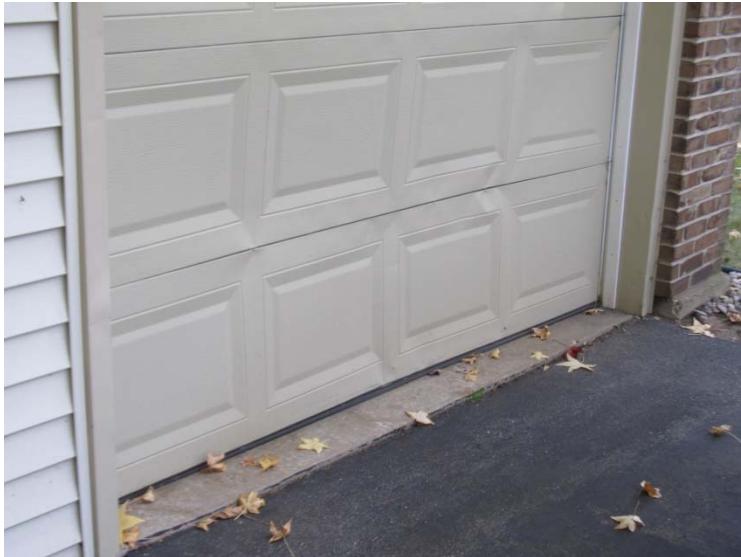
Doors, Garage - The Association maintains the 186 metal single and double garage doors. The garage doors are in good overall condition at various ages. We note isolated dents and finish deterioration as shown on Page 5.5 of **Photographs**. The garage doors have a useful life of up to 25 years. We recommend the Association anticipate a phased replacement of the garage doors beginning by 2030 and concluding by 2032. We note this information on Line Item 1.200 of **Reserve Expenditures**. We recommend replacement with insulated doors to provide structural rigidity to the panels. The Lakes of Woodbridge should aggregate replacement of the garage doors to ensure their availability and to maintain aesthetic continuity throughout the community. Unit owners maintain the electric operators.

Garage door damage at 7687 Blackmar Circle

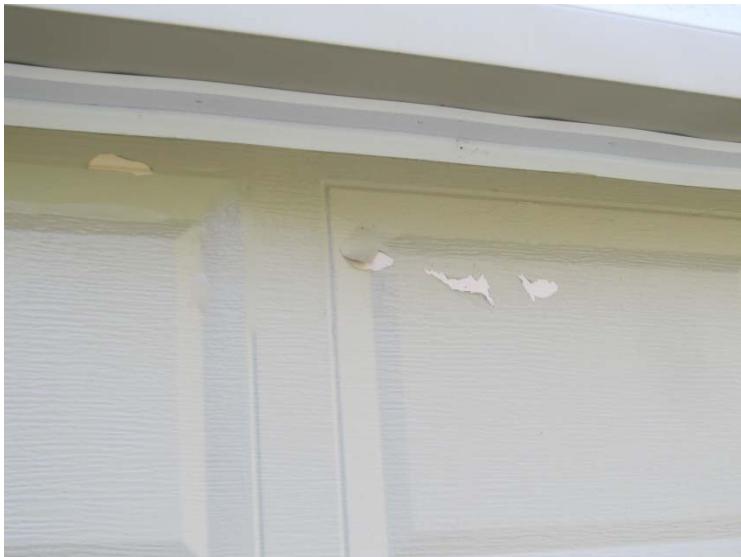
Finish deterioration at 3662 Tartan Circle

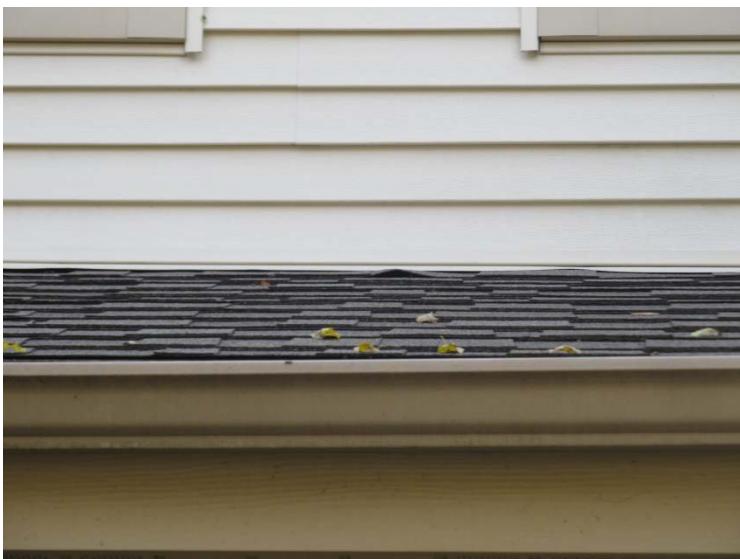
Shingle lift at 3689 Woodbridge Lane

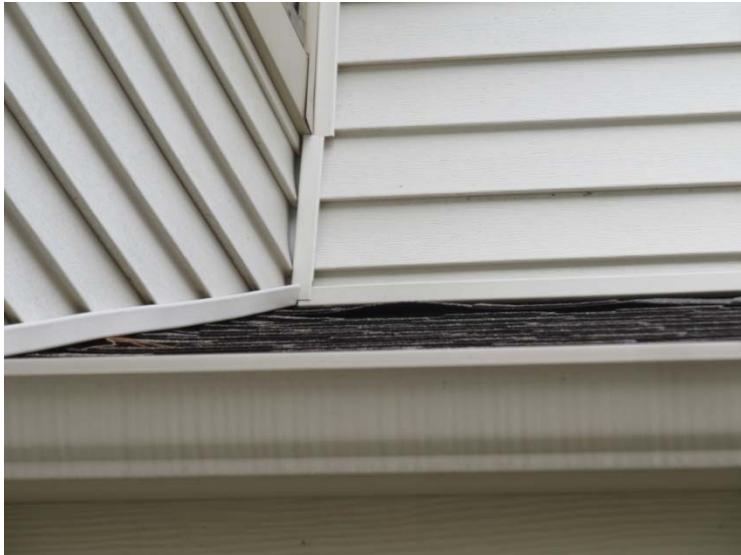
Shingle lift at 3740/3742 Tartan Circle

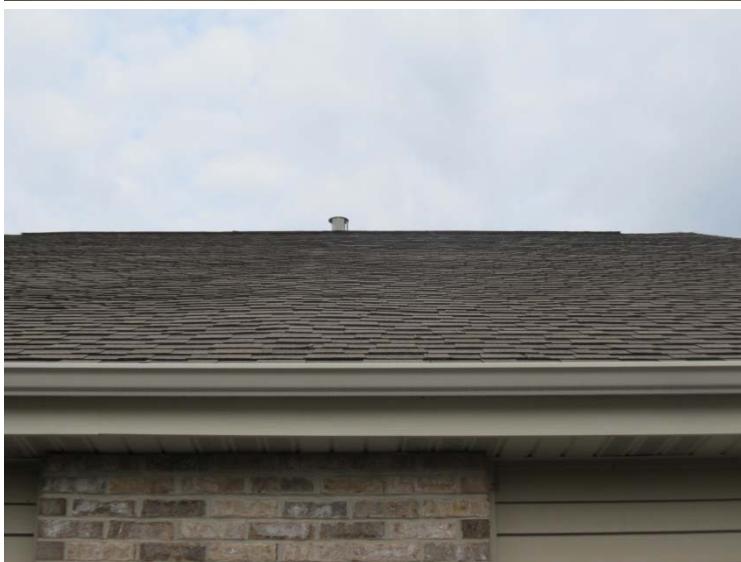
Shingle lift at 7623 Blackmar Circle

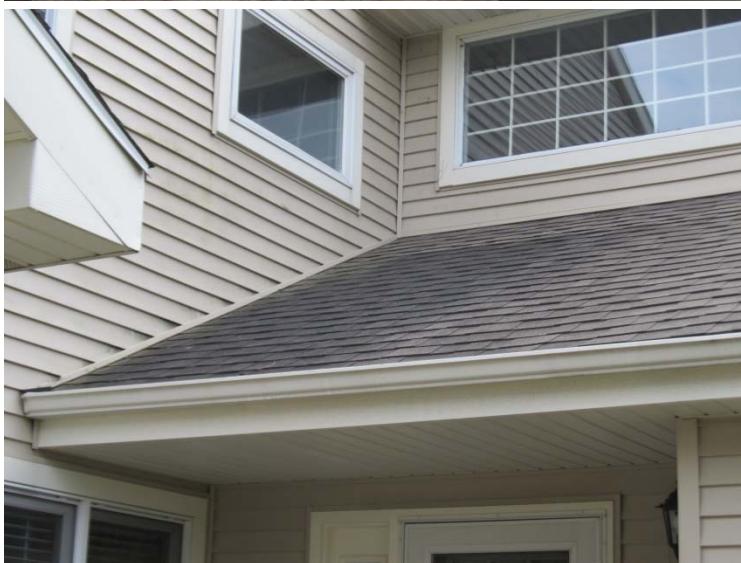
Sheathing deflection at 7563/7565
Woodbridge Lane

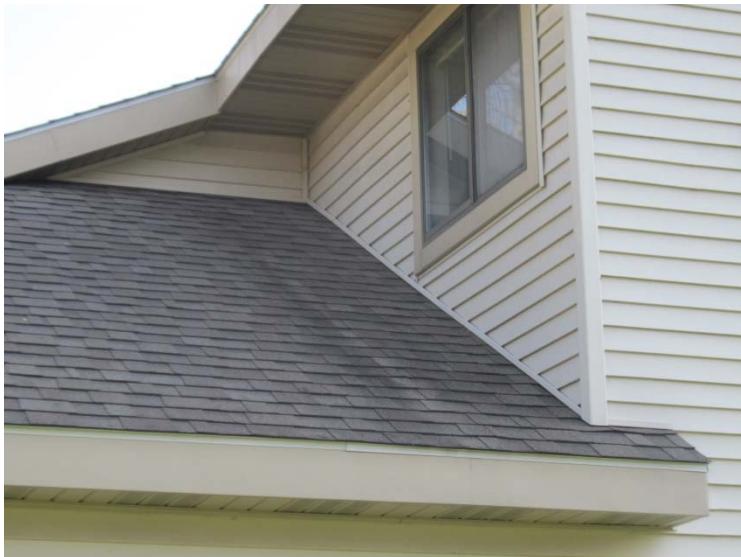
Shingle discoloration at 7692 Vernard
Circle

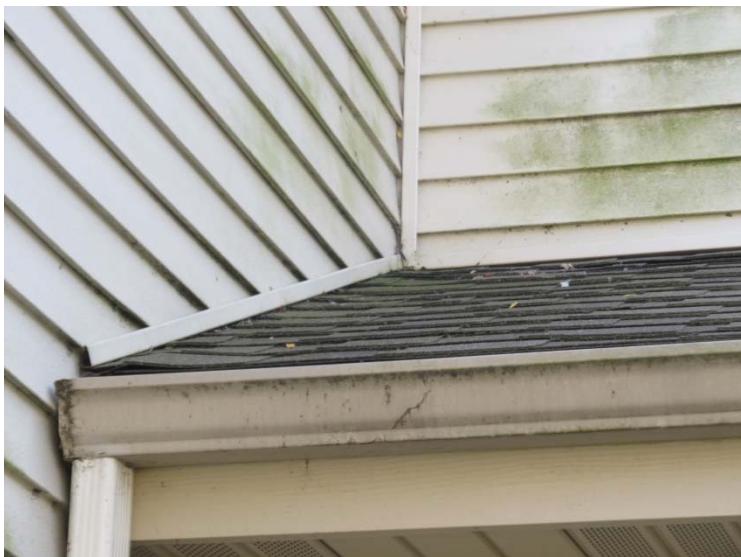
Shingle discoloration at 3744 Tartan Circle

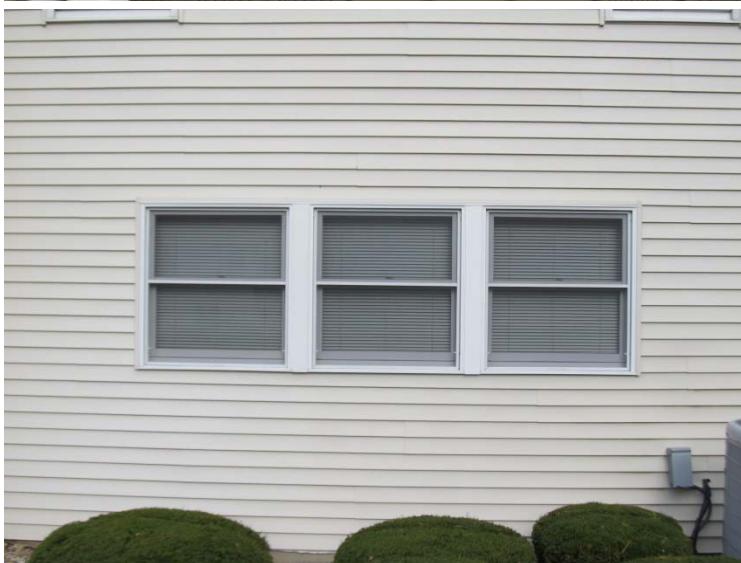
Organic growth at 7478/7450 Tartan Circle

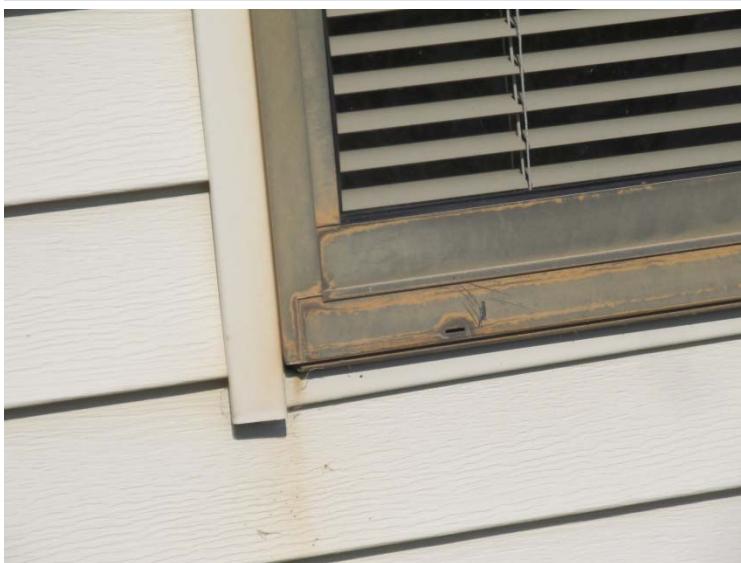
Window frame deterioration at 7671
Blackmar Circle

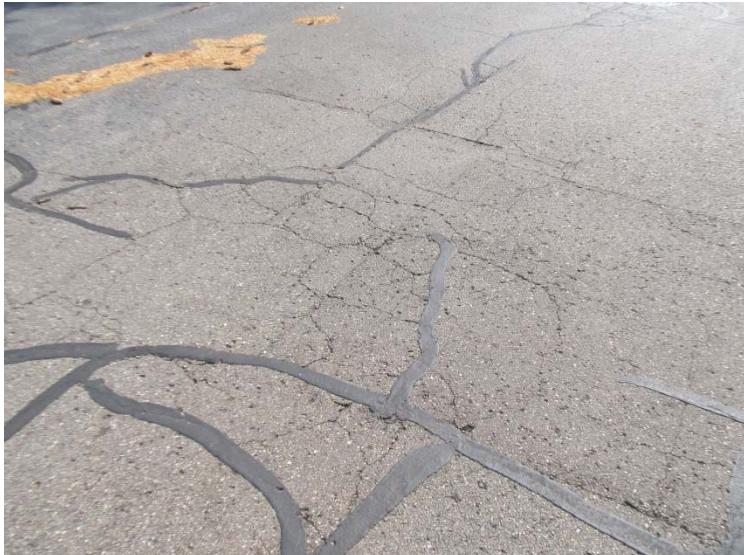
We note cracks, deterioration and settlement as shown on Pages 5.10 through 5.13 of ***Photographs***. The useful life of pavement in Portage is from 15- to 20-years. We include the following repaving solutions and procedures for the benefit of the present and future board members.

Cracks at Tartan Circle

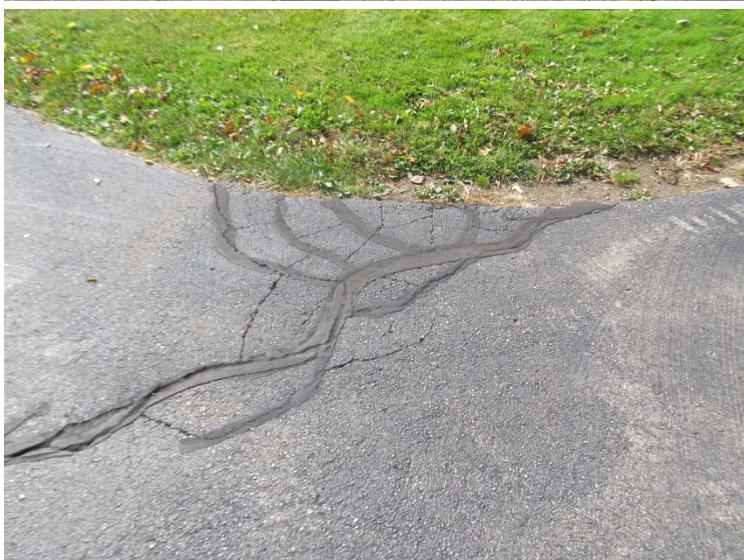
Cracks at Tartan Drive

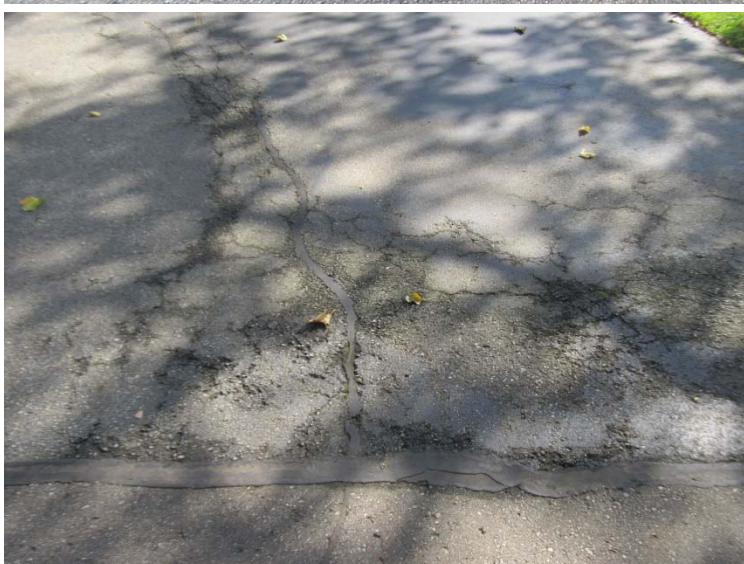
Cracks at Kirkaldy Circle

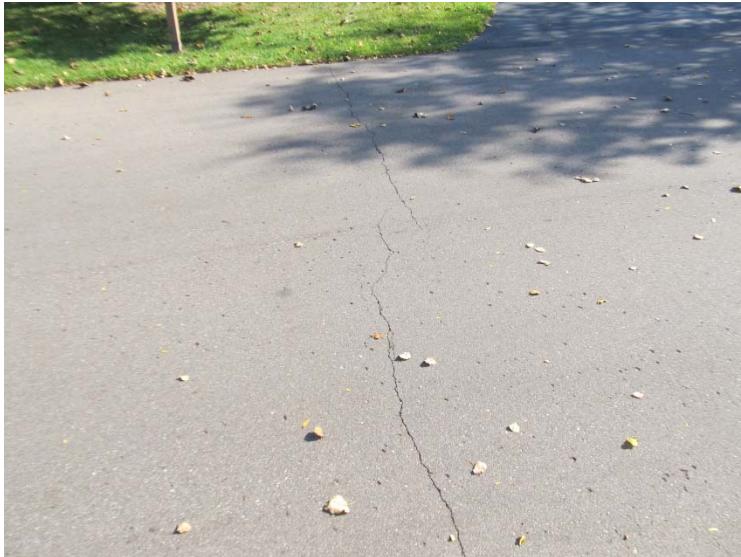
Driveway deterioration at 7647/7651
Blackmar Circle

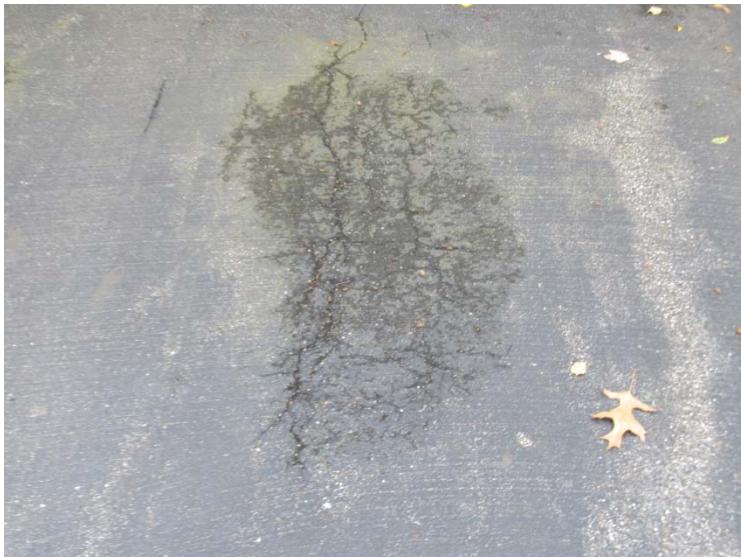
Crack at Woodbridge Lane

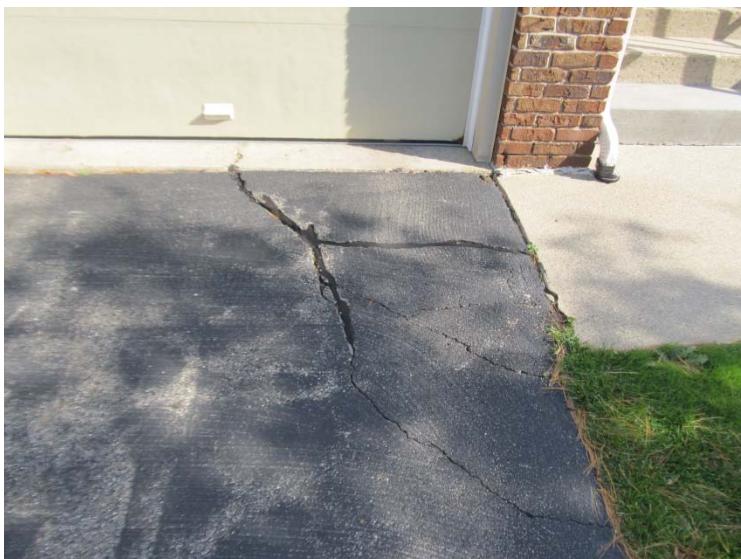
Driveway settlement at 3762/3764 Tartan Circle

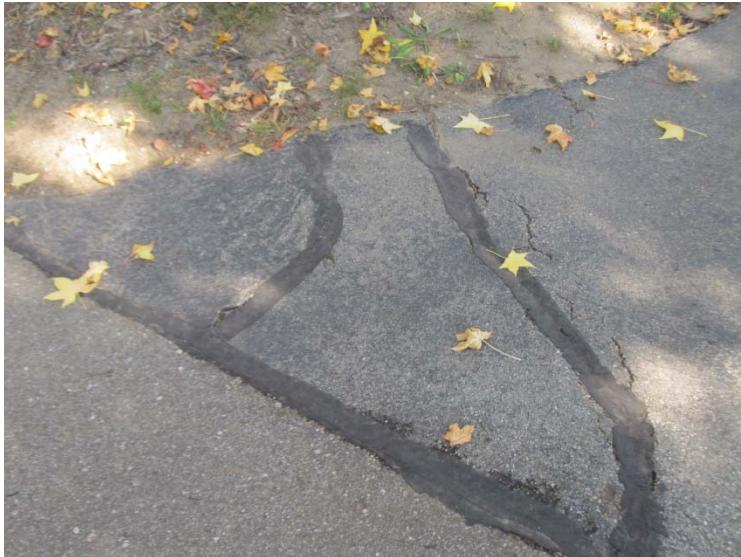
Driveway cracks at 3601 Tartan Circle

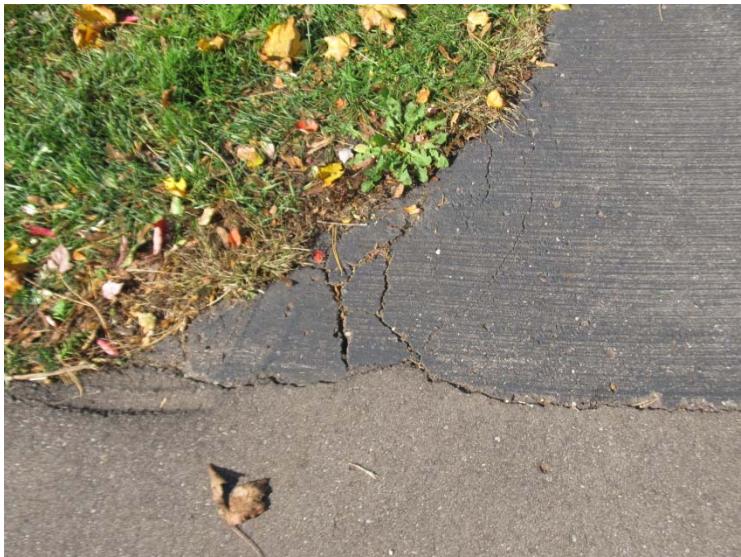
Driveway cracks at 7679/7683 Blackmar Circle

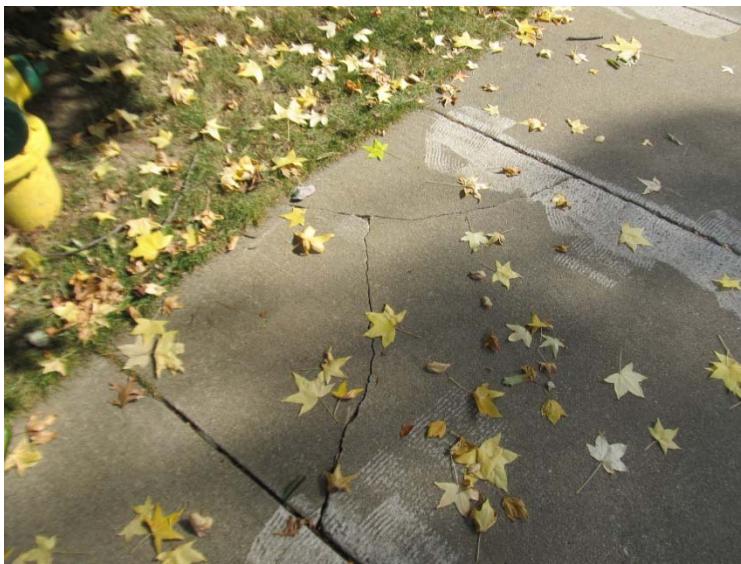
Sidewalk crack

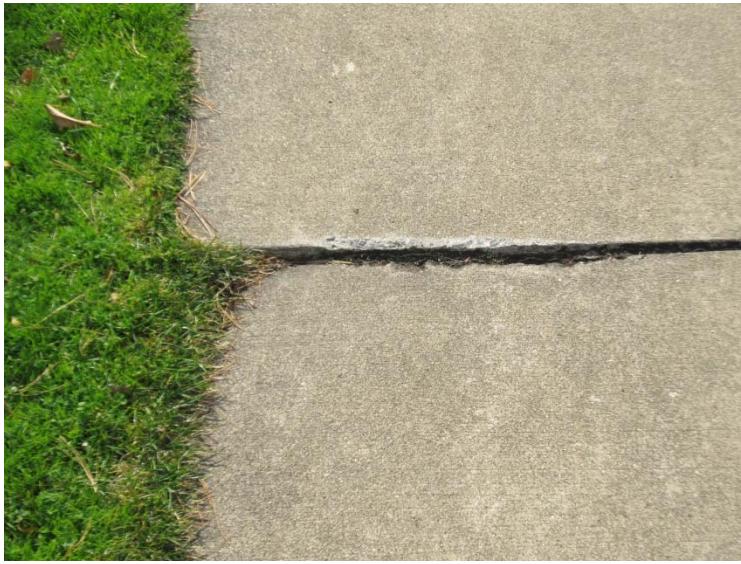
Sidewalk Cracks

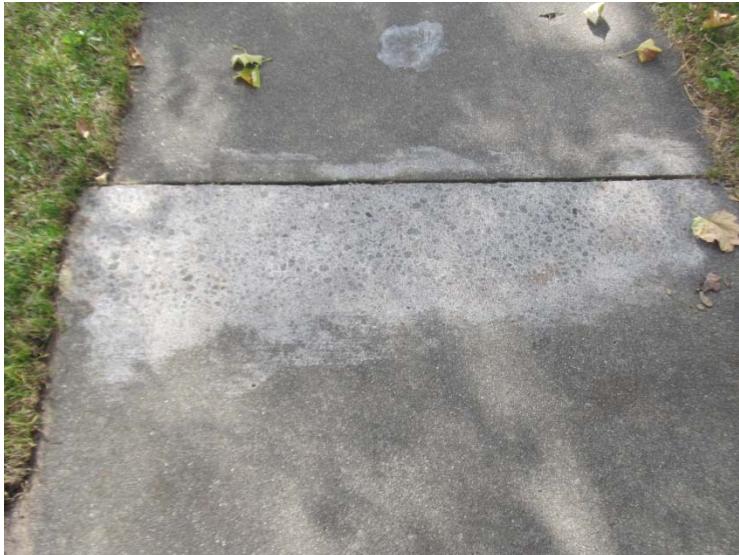
Sidewalk settlement

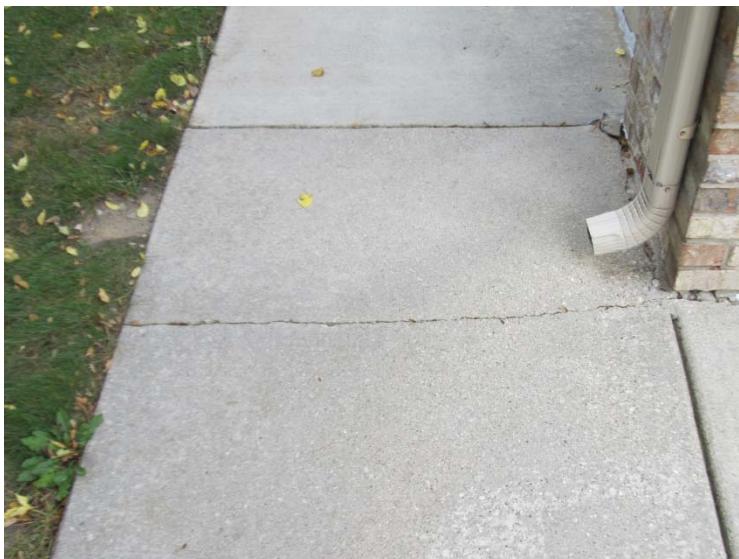
Spalled concrete

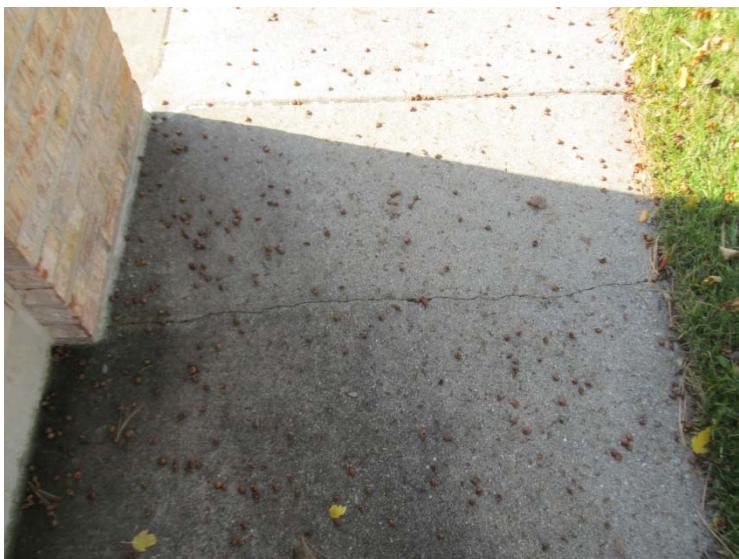
Sidewalk crack at 7063 Woodbridge Lane

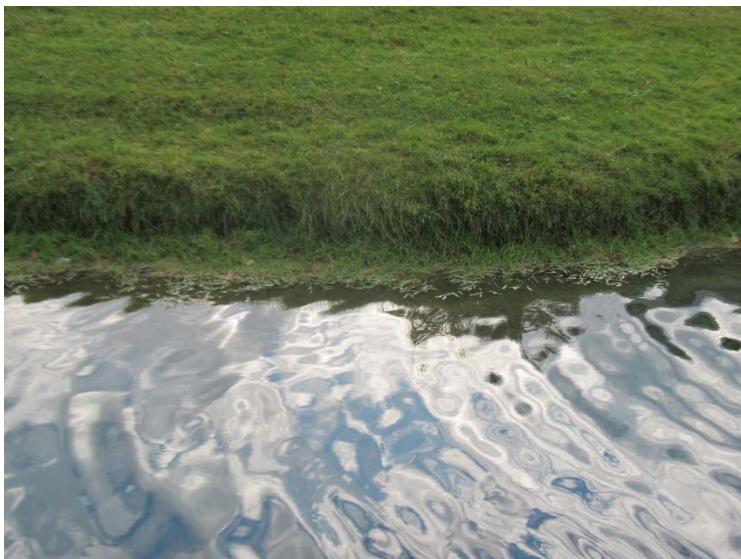
Shoreline erosion at north pond

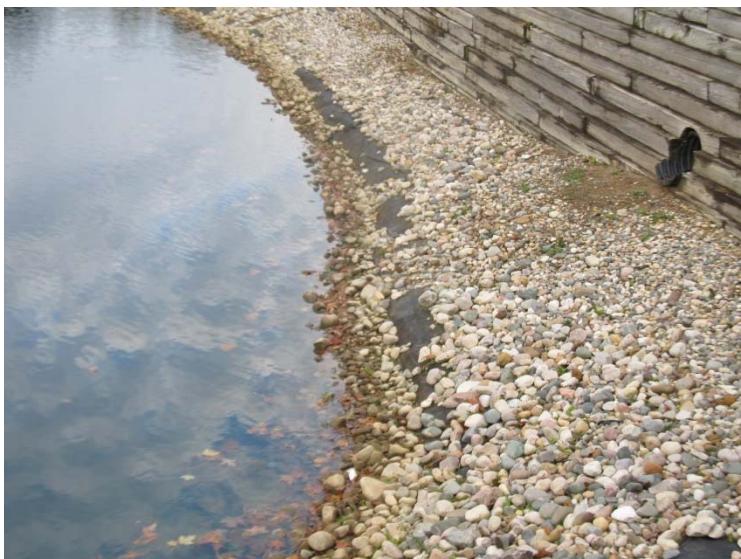
Shoreline erosion and vegetation growth at north pond

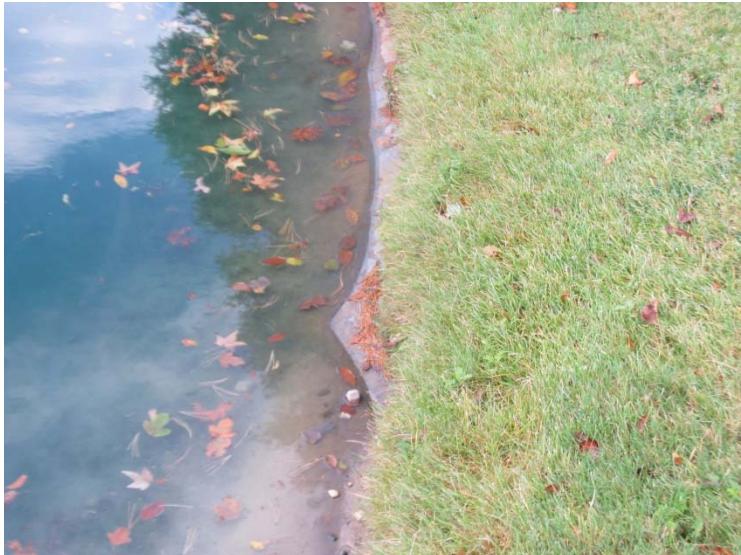
Loss of stone rip rap at south pond

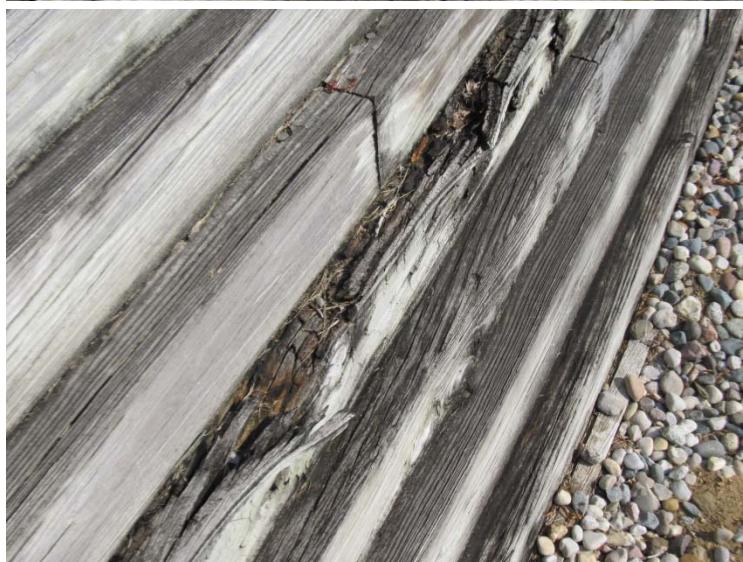
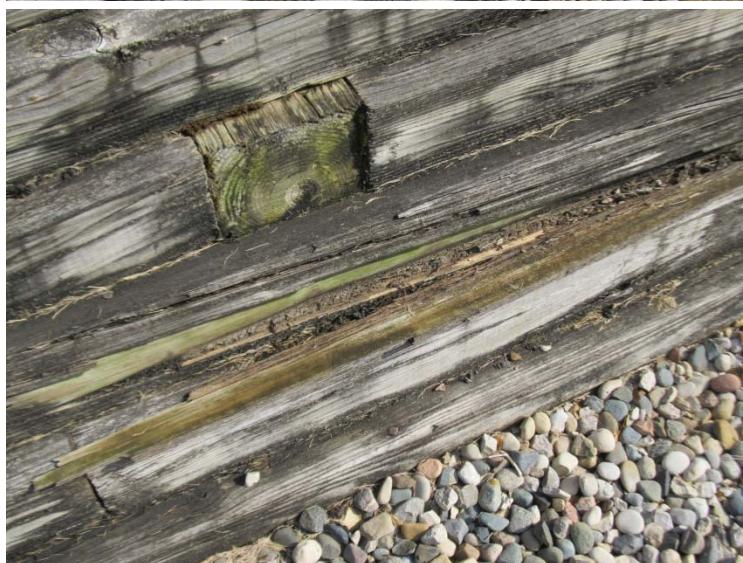
Retaining Walls, Timber - The Association maintains multiple retaining walls which comprise approximately 2,940 square feet of wood timbers. The retaining walls are original and in poor overall condition. We note wood damage as shown on Page 5.20 of **Photographs**. Timber retaining walls have a useful life of 15- to 20-years. We recommend the Association anticipate replacement in 2016. We advise The Lakes of Woodbridge replace with a modular, interlocking *dry-set masonry retaining wall* system. The following schematic depicts this type of retaining wall:

Wood damage

The cost of *dry-set masonry retaining walls* is similar to the cost of timber walls. However, dry-set masonry retaining walls offer a longer useful life of up to 35 years and lower total maintenance costs. We include this information on Line Item 4.760 of **Reserve Expenditures**.
